# Atlantic Richfield Company

April 18, 2017

**RE: Leviathan Mine Site: Revised Update on Limited Access Season Site Conditions  
April 5 - 12, 2017**

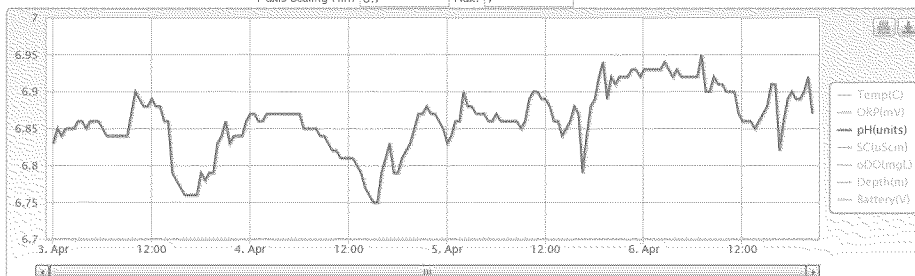
It appeared from the photos that the separation may have resulted from ice pushing against the riser pipe assembly. Atlantic Richfield does not normally have personnel at the site at this time of year, and the pipe separation was not the result of any human-caused activity. It also appeared that there were only a few inches of standing water in Pond 4 above the pipe separation, and the section of pipe below the separation was intact. According to Doug Carey, LRWQCB Board crews who were at the site earlier in the week did not observe any discharge from the Pond 4 overflow pipe, so we assume the separation occurred sometime between April 4 and April 6, 2017. pH measurements from EPA's data sonde in Leviathan Creek at 4L did not suggest that the resulting discharge from Pond 4 was having any significant effect on surface water quality during this time:

At 5:49 PM PDT on April 6, 2017, Atlantic Richfield notified EPA of these conditions by email. Atlantic Richfield also described its plan for repairing the pipe separation by sending field personnel to the site the following day, weather permitting.
